# The Art of Listening

## Case Study

In autumn 2008 we were approached by the church of The Immaculate Heart in Middlesex to investigate the unsatisfactory level of gain before feedback and speech intelligibility being offered by their installed sound system.

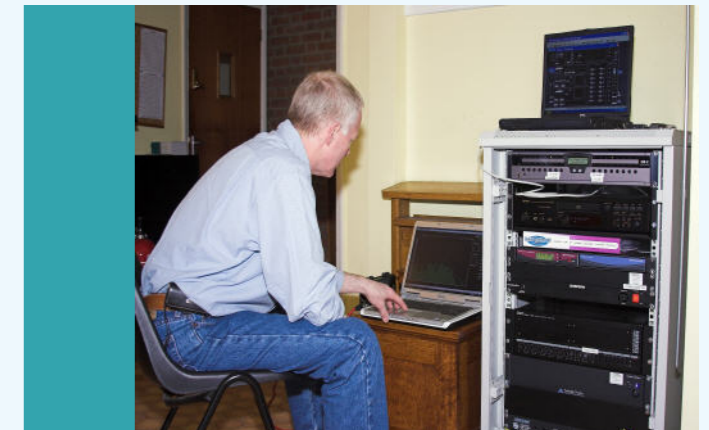
Using the real time analyser

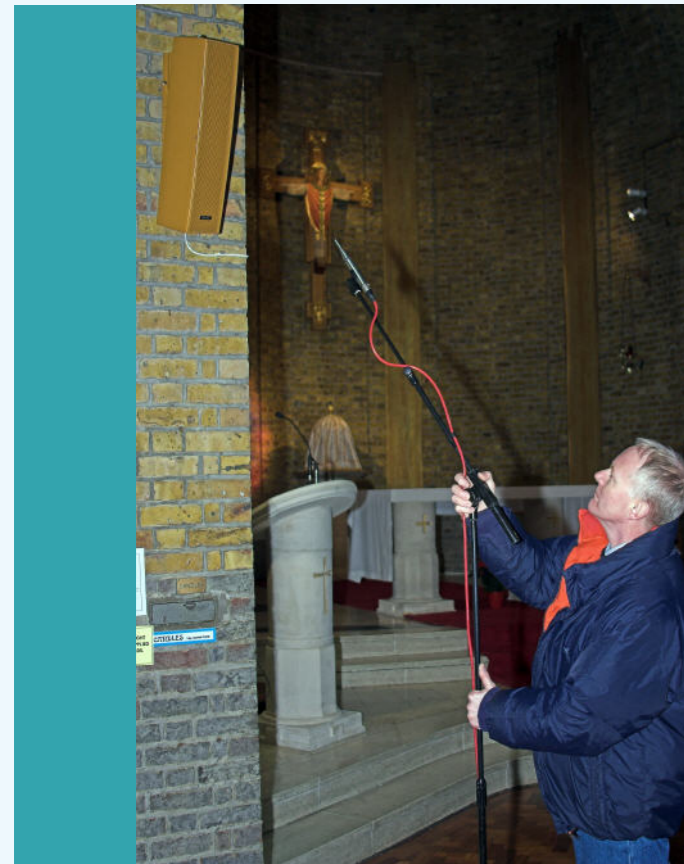
setting up the calibrated microphone

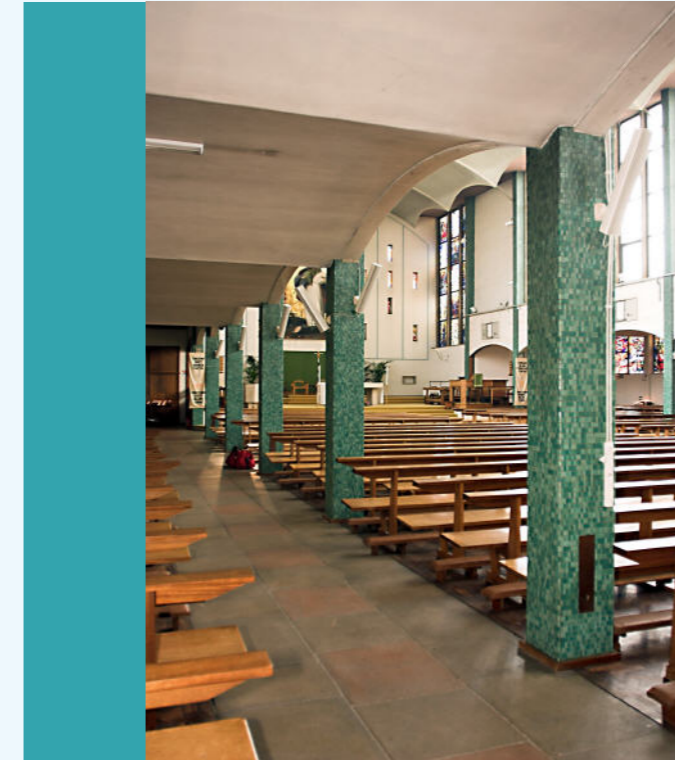
Correct downward angle is essential

In most cases the loudspeakers were contributing to the problem by being installed incorrectly making it impossible to achieve the desired angle necessary to

make use of the dispersion characteristics of the loudspeakers that would provide the correct audio coverage.
